Comparing Manned Aerial Surveys to Unmanned Aerial Surveys for Cetacean Monitoring in the Arctic: Field Report

Robyn Angliss¹, Megan Ferguson¹, Phil Hall², Van Helker³, Amy Kennedy⁴, Todd Sformo⁵

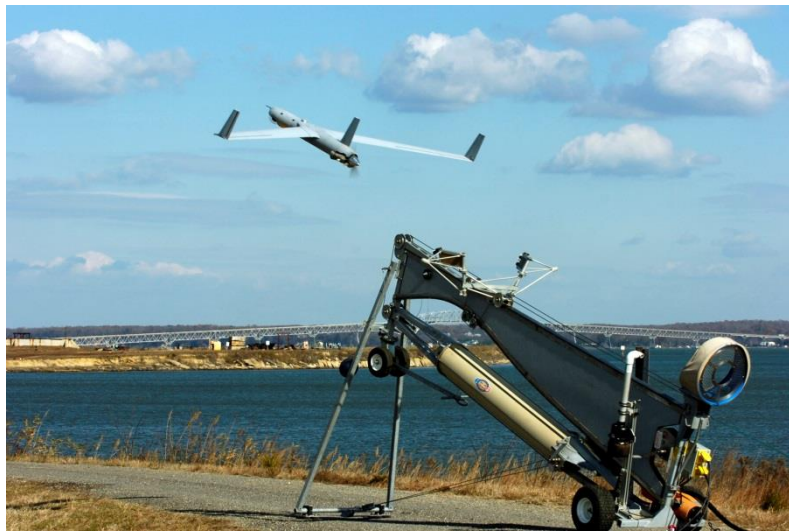
Figure 2. ScanEagle® on launch at Naval Surface Warfare Center – Dahlgren Division

The mission used two ScanEagle® UAS manufactured by Insitu, Inc. (Figure 2). All pilots were trained by Insitu and had Letters of Authorization designating them as approved ScanEagle® UAS pilots by a US Navy Squadron. ScanEagle® dimensions and performance characteristics are included in Table 1.

Launch system. The SuperWedge® Launcher was used to launch the aircraft (Figure 2). The launcher is charged by an attached air compressor. The UAV is launched by removing the safety pin and then the catapult is manually activated using a pull trigger. On firing, the launcher accelerates the UAV, and at the end of the rail, the UAV is launched at takeoff speed.

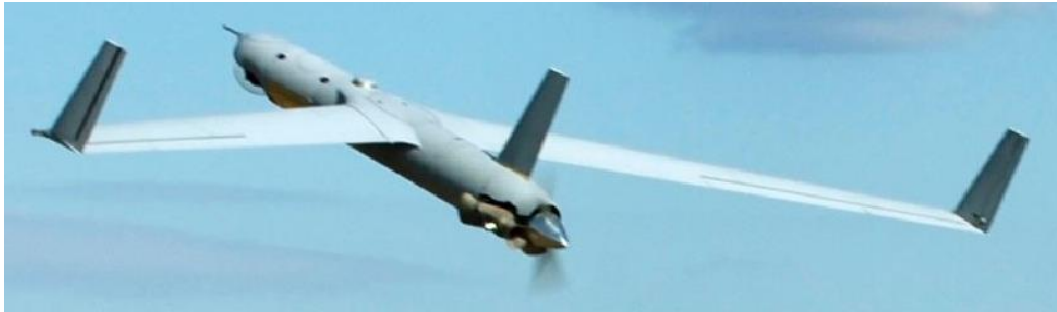
Figure 3. ScanEagle® UAV

The ScanEagle® UAV is a long endurance aircraft composed of modules that are replaceable at the field site. The ScanEagle® UAV (Figure 3) is a tailless aircraft that features a high aspect ratio swept wing. It has a rear-mounted engine driving a pusher propeller. Two sets of elevons on the wings provide pitch and roll control, with rudders on the winglets at the wing tips for directional control.

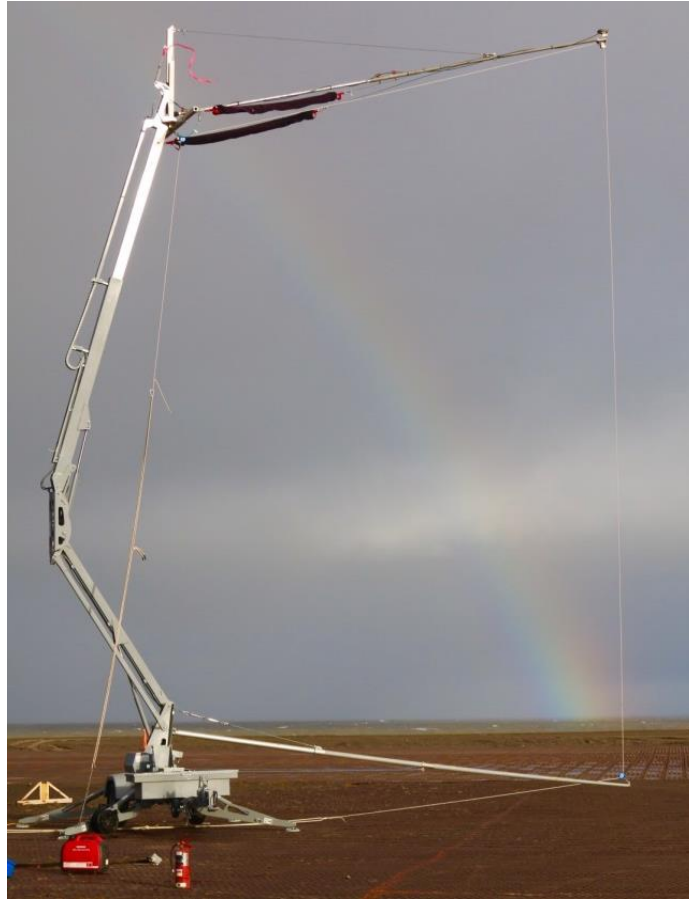
Figure 4. Skyhook® retrieval system, Barrow AK.

Retrieval system. The SkyHook® retrieval system (Figure 4) captures the UAV. The SkyHook® system uses a GPS receiver and antenna to make an accurate approach via data relayed through the control station. The aircraft is captured by flying into a rope suspended approximately 45 feet above the surface. A hook on the wingtip catches the line and quickly stops the aircraft.

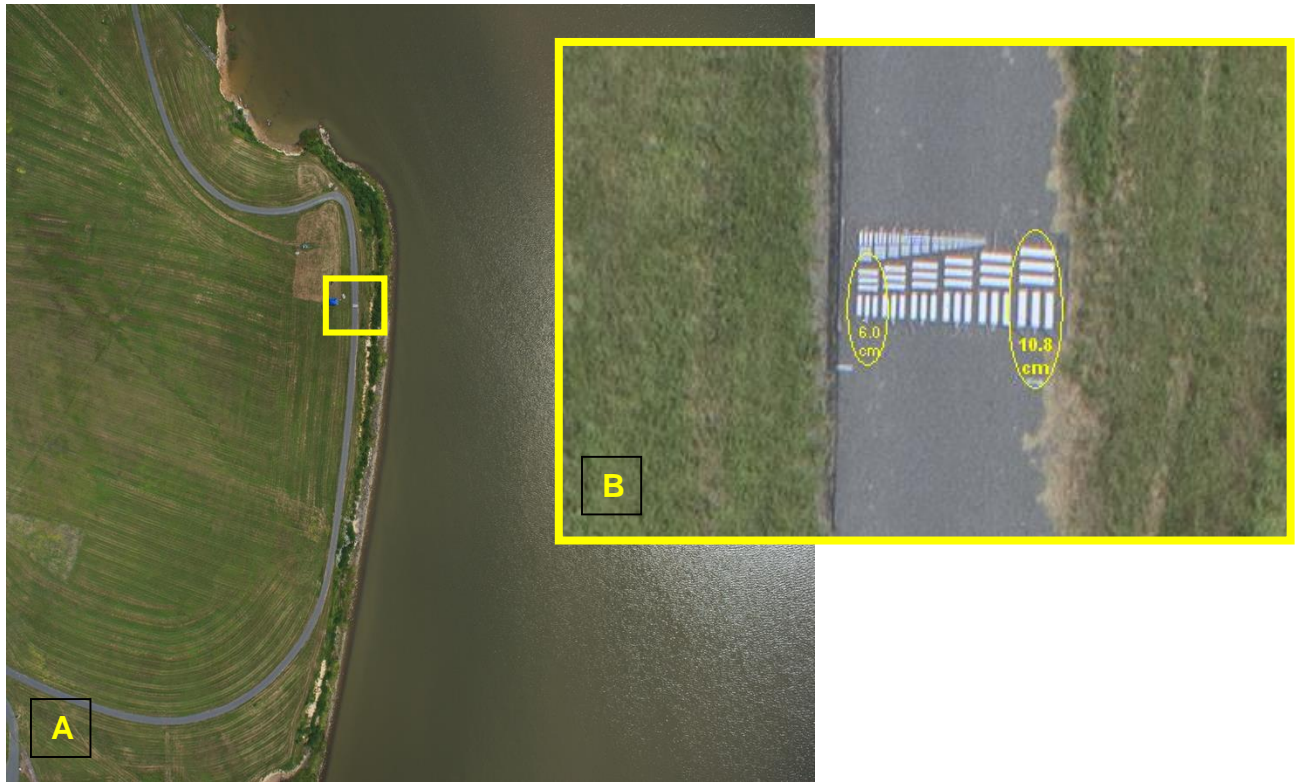
Figure 5. Image A was taken from the UAS during the test flight in Dahlgren, VA at 1050 ft AGL and 60 kts ground speed. Image B shows the calibration target at 300% zoom, with circles around the 6 cm wide and 10.8 cm wide calibration tribars.

The Nikon D810 and 20 mm Nikkor lens was flight tested at NWSCDD on 21-22 July 2015. The UAS overflew a tri-bar calibration target at pre-determined altitudes in order to assess the accuracy of the camera system. In addition, the tests were necessary to ensure that the pilots could determine whether the camera was firing. The bars on the calibration target ranged from 0.5 cm wide to 10.8 cm wide. During the test flights, images taken at 1050 ft AGL and 60 kts showed an image resolution of 6 cm (Figure 5).

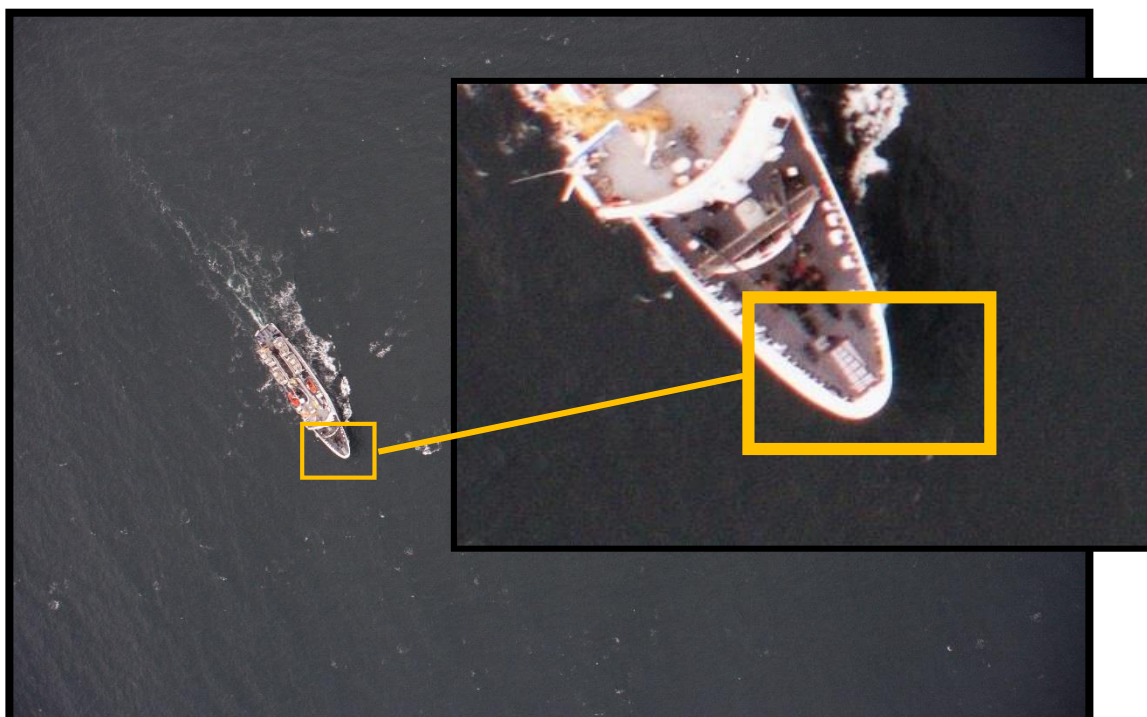
Figure 10. Calibration target on the NOAA Ship *Fairweather*, photographed from the UAS at 997 ft MSL. The yellow boxes indicate the location of the calibration target, and a zoomed insert of the target. The largest bar measures 53.9 cm by 10.8 cm, yet none of the calibration bars are distinguishable.

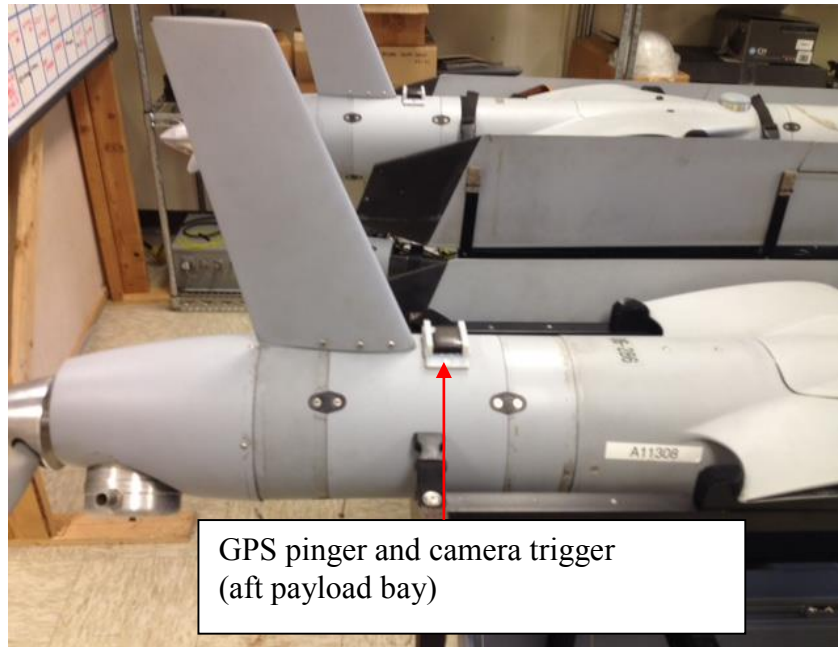
Figure 15. Aft payloads in the ScanEagle®

3. EO board camera (14): The EO board camera provided the UAS operator with situational awareness during flight.
4. GPS pinger (15): The GPS pinger was intended to aid in recovery of the UAS in the event of a controlled water landing. The GPS pinger also allowed for GPS metadata to be included with the images taken with the D810 camera.

5. Camera trigger (15): The camera trigger was intended to allow for the D810 camera to have pictures taken based on GPS distance instead of using the camera timer.

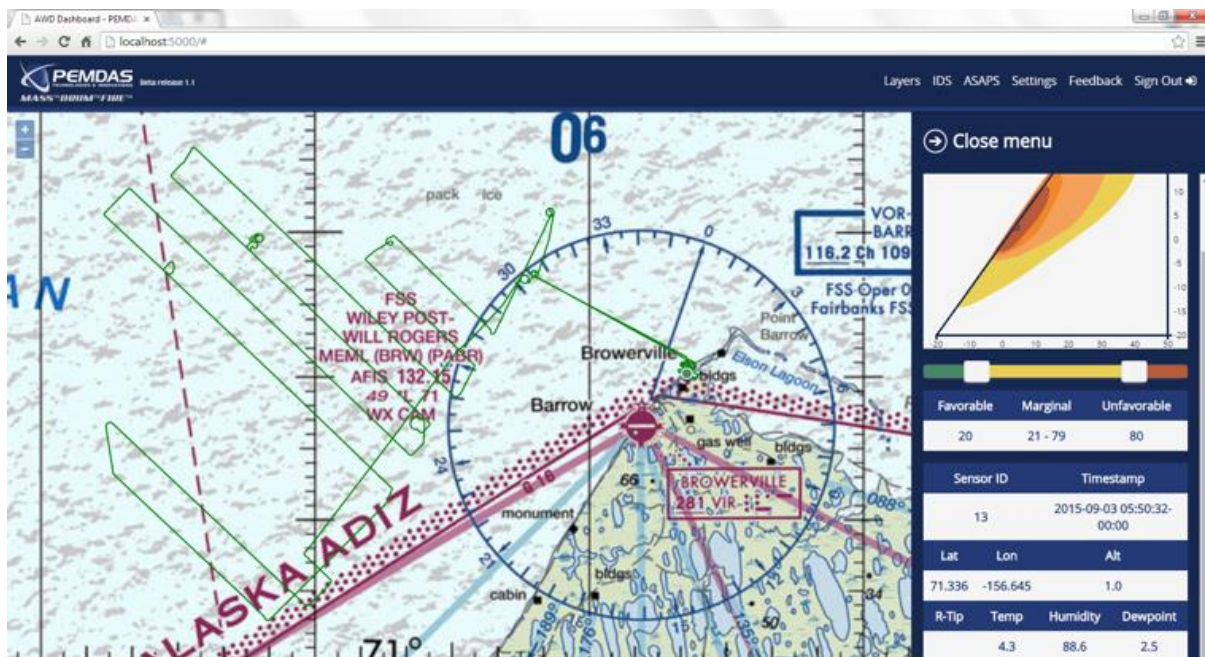
Figure 16. Screenshot from nowcasting and ASAP sensor. The display shows the ScanEagle® flight path with live display of carburetor icing threat, altitude, temperature, humidity, and dewpoint.

PEMDAS provided a real-time carburetor icing diagram (Figure 16; upper right hand side of the screenshot). Changes to the way the ScanEagle® was flown were based on this carburetor icing information. For example, the data reflected that the ScanEagle® was almost always in critical carburetor icing. The decision was made to fly at a higher speed/RPM to decrease the likelihood of ice formation. Due to the high risk, additional monitoring of RPM was implemented.
